# Investigation of Gear and Bearing Fatigue Damage Using Debris Particle Distributions

Paula J. Dempsey  
Glenn Research Center, Cleveland, Ohio

David G. Lewicki and Harry J. Decker  
U.S. Army Research Laboratory, Glenn Research Center, Cleveland, Ohio

Prepared for the  
60th Annual Forum and Technology Display  
sponsored by the American Helicopter Society  
Baltimore, Maryland, June 7-10, 2004

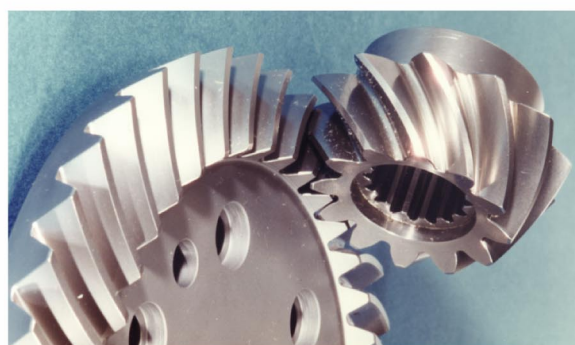
Gear damage

Bearing damage

Figure 2.—Spiral bevel gear fatigue rig.

A representative example of the damage observed on the pinion during spiral bevel gear testing is shown in Figure 2. Pitting damage to the pinion occurred during all experiments. However, during one experiment, bearing damage also occurred. This is also shown in Figure 2.

Experimental data were recorded from tests performed in the Spiral Bevel Gear Test facility at NASA Glenn Research Center [12, 13]. The Spiral Bevel Gear Test Facility is illustrated in Figure 2. The main purposes of this test rig are to study the effects of gear material, gear tooth design, and lubrication on the fatigue strength of gears. The facility uses a closed loop torque-regenerative system. Two sets of spiral bevel gears can be tested simultaneously. Fatigue tests are performed on aerospace quality gears under varying operating conditions. The 12 tooth pinion and 36 tooth gear have 13.06 cm diametral pitch, 35 degree spiral angle, 2.54 cm face width, 90 degree shaft angle, and 22.5 degree pressure angle. Tests are performed for a specified number of hours or until surface fatigue occurs. The gearbox has a window enabling the test gears to be inspected periodically for damage using a strobe.
